# access to the environment

Case Studies of Barrier Free Sites

Volume 2

**Case Studies of Barrier Free Sites**

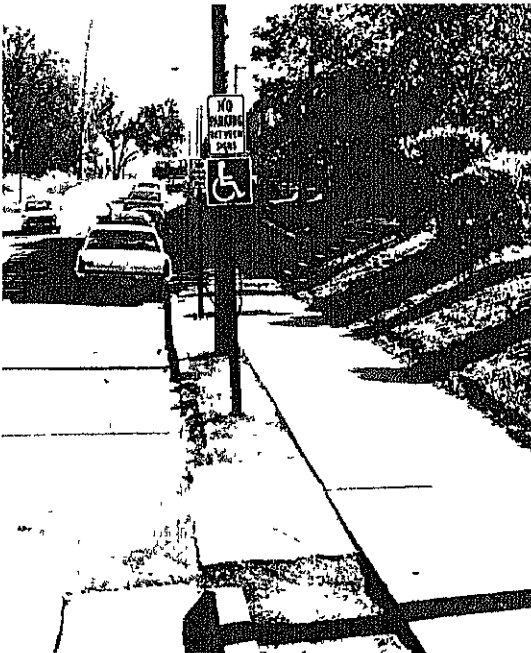
Yellow lines and yellow arrows are used to indicate appropriate points for crossing grade changes and traffic routes. All dropped curbs are marked by this yellow painted arrow point.

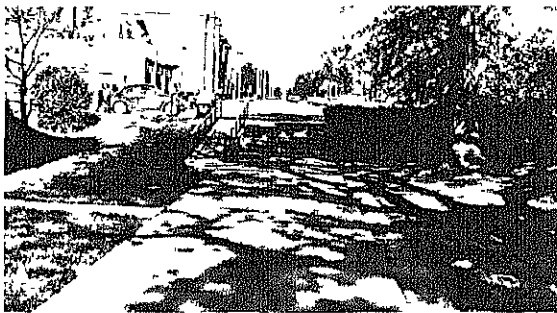
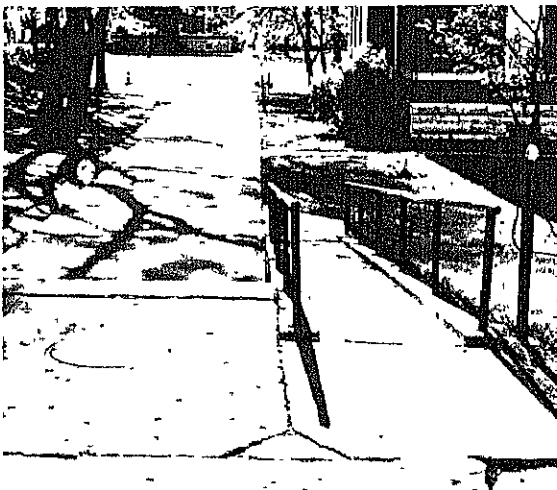
Curb cuts or curb alterations have been made throughout the campus. Essentially two forms of curb cut have been used. One is a straight curb cut with ramping, the other is an offset dropped curb and ramp. Photographs show several varieties.

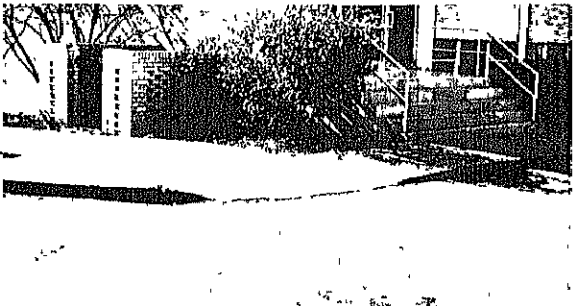
Sidewalks and other pathways throughout the campus have been made passable for the handicapped. Permanent ramps may be either integral or additive, temporary ramps may be stationary or portable.

It should be noted that the ramps have made all pathways easier to traverse by bicycle. This has both positive and negative aspects - while serving a large number of students, a conflict is created between the various wheeled vehicles - the slow wheelchair and the much faster bicycle.
